# **LAKE WALLENPAUPACK WATERSHED MANAGEMENT PLAN**

**December 2006**

**Lake Wallenpaupack Watershed  
Management District**

**F. X. Browne, Inc.  
*Engineers - Planners - Scientists*  
Lansdale, Pennsylvania**

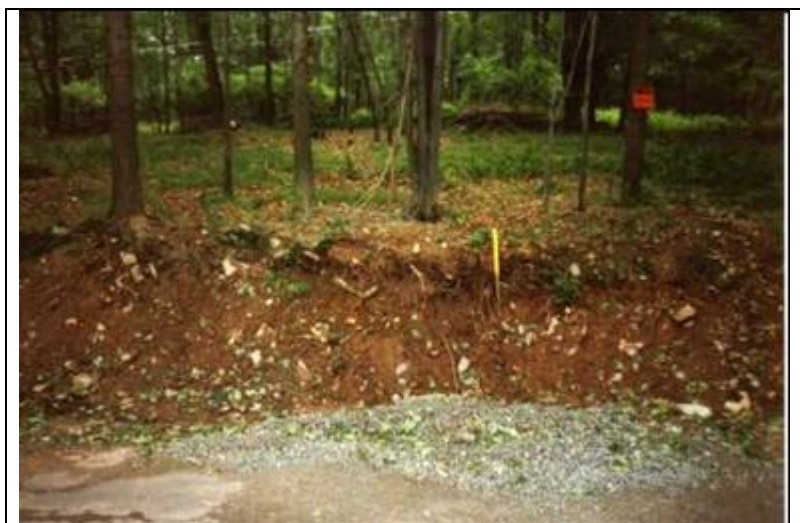
Roadside bank erosion problem area

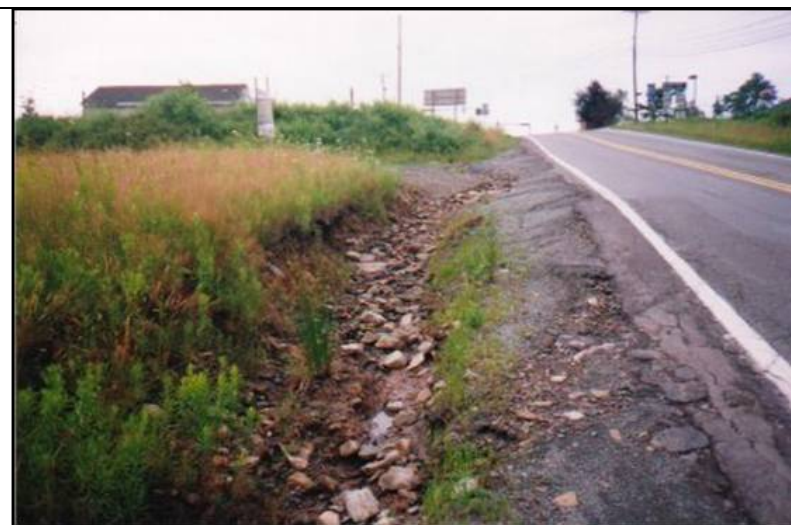
Roadside in need of repair and stormwater management

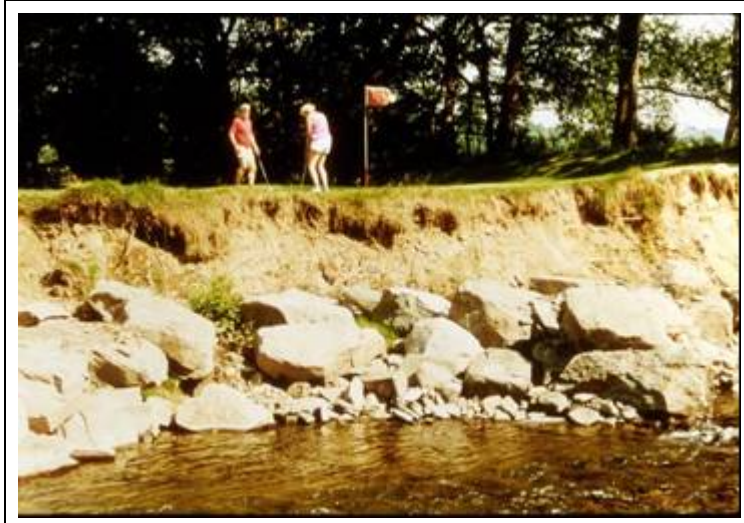
Streambank erosion problem area along Wallenpaupack Creek before restoration

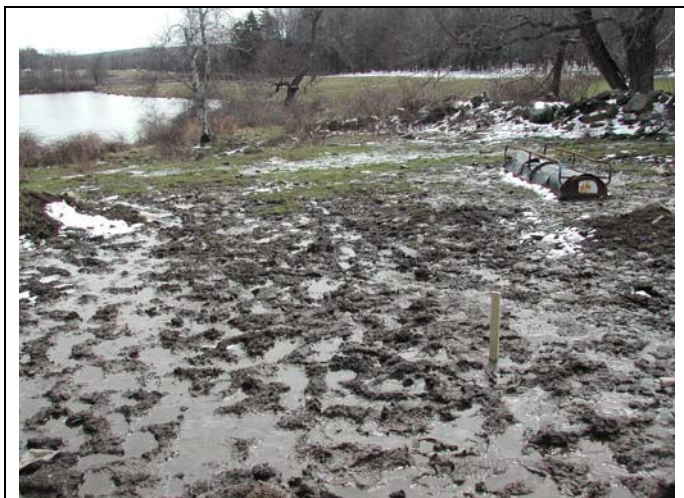
Barnyard in need of heavy use area protection

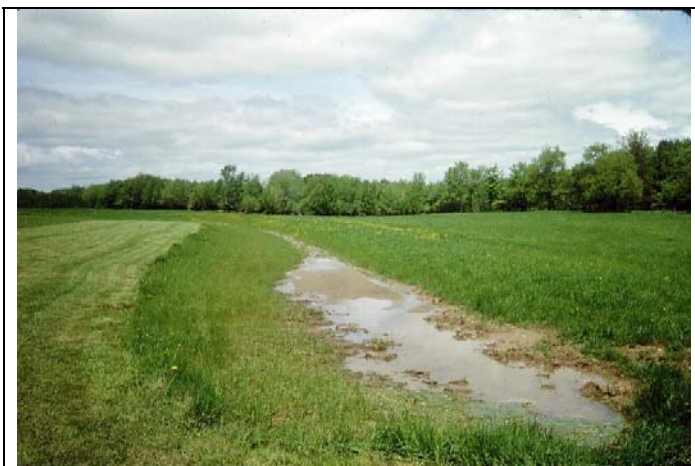
Grassed waterway installed on Kraeger Farm

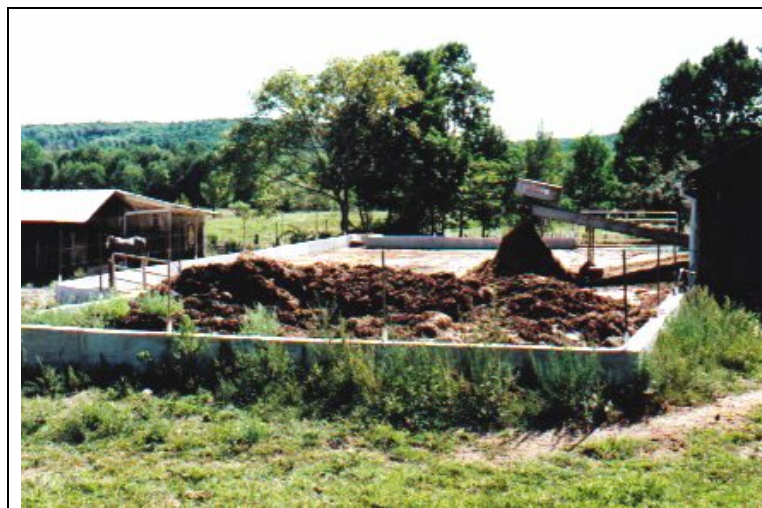
Agricultural waste facility on Held Farm, Jefferson Township

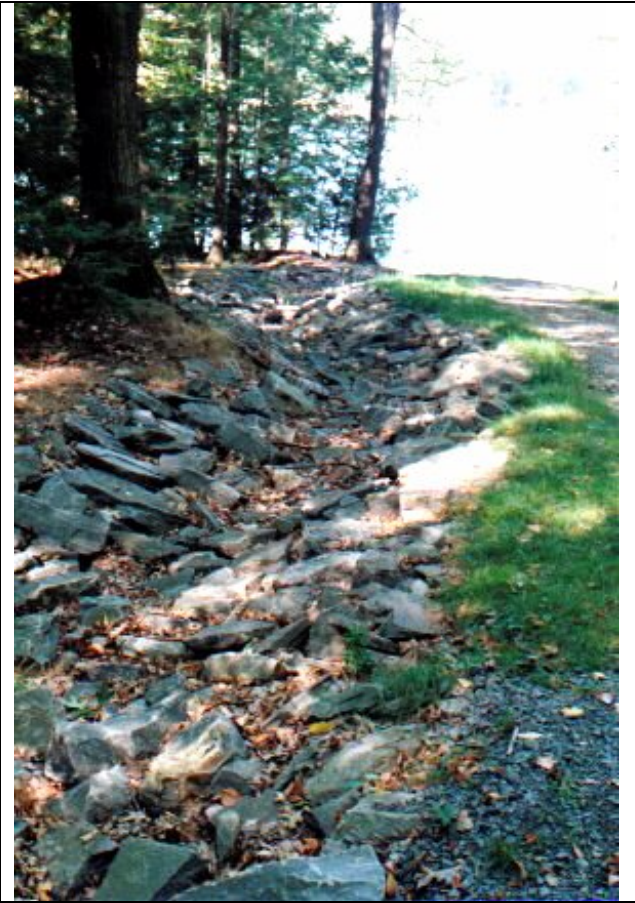
Rock-lined channel designed to reduce stormwater erosion along roadside in Paupack Township

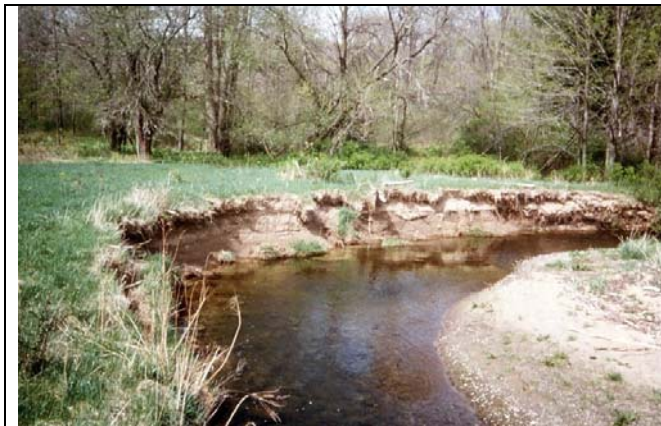
**Butternut Creek Before Stabilization**

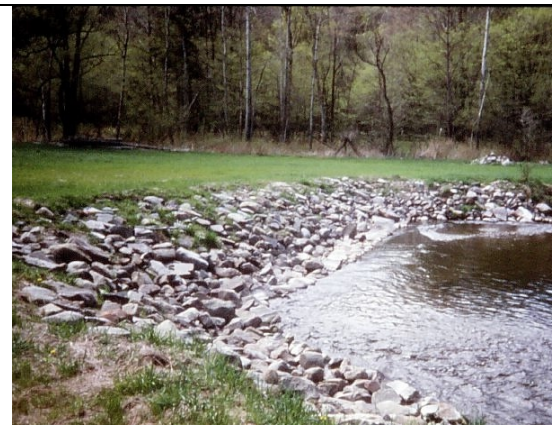
**Butternut Creek After Stabilization**

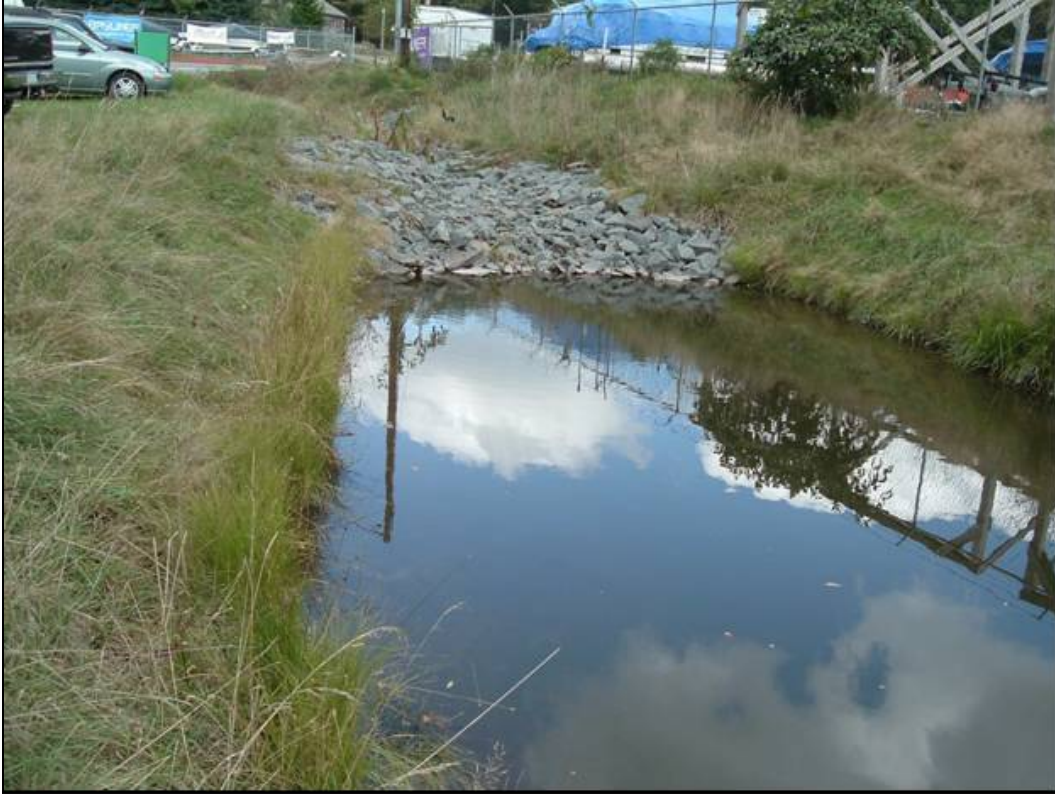
For the project, the existing detention basin was converted to a constructed stormwater wetland system to receive and treat the site runoff. The project was constructed in 2000. The wetland consists of six sediment forebays and a large basin. The outlet of the wetland is directed into a rock channel along the roadside. The goal of the BMP is to not only slow the stormwater velocity, but also to retain some stormwater for nutrient and sediment removal and peak flow reduction. The photos below show the constructed wetland post-construction and after wetland plant establishment.

**Sediment Forebay at Constructed Wetland Inlet – after BMP installation**

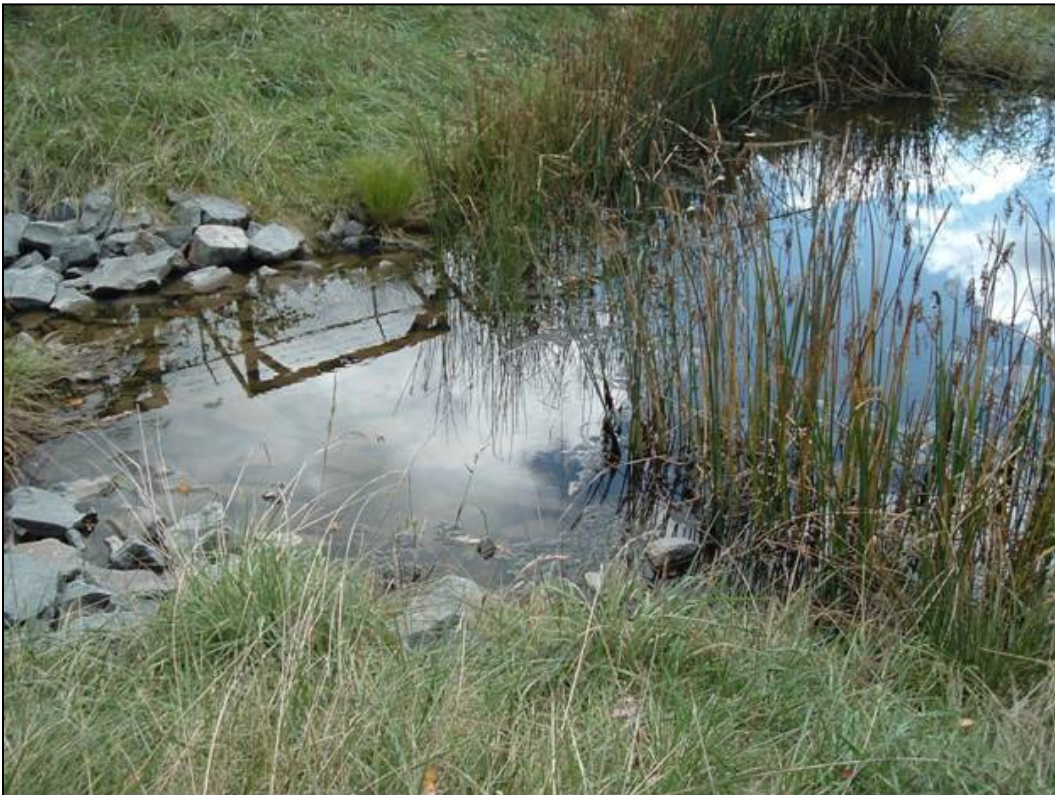
It should be noted that it took several years for the wetland plantings to become well established, but they are thriving now.

**Wetland Plantings Help Filter Stormwater and Trap Sediment**
